Failure of the Trailing Umbilical System Disconnect Actuator on the International Space Station

Abstract

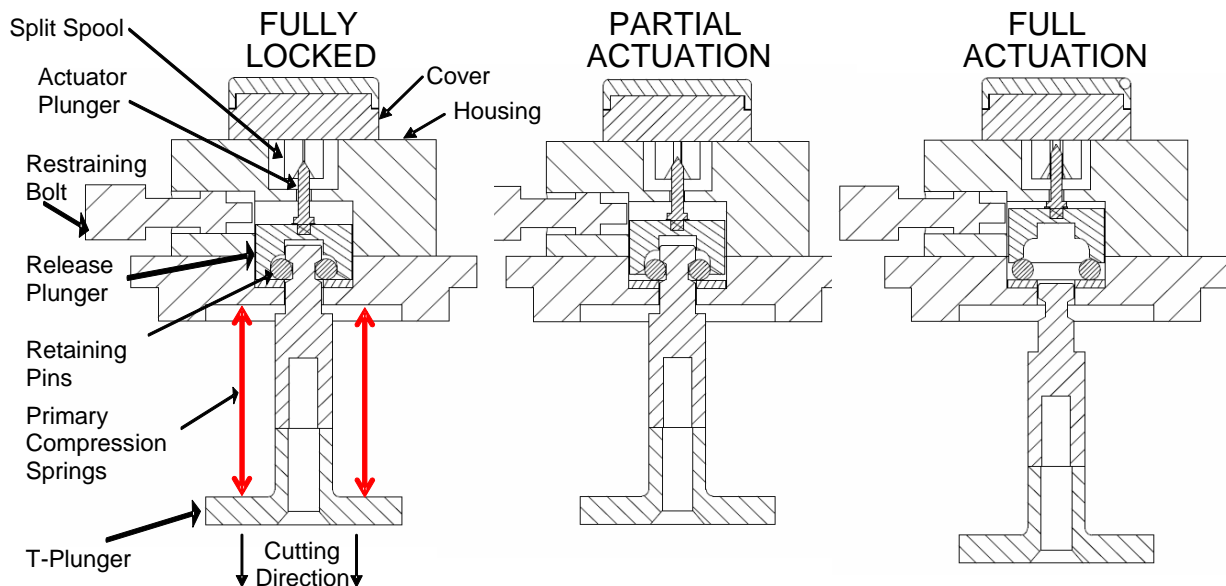
Figure 3. Actuation of the TUS Disconnect Actuator

The Restraining Bolt is used to prevent inadvertent actuation during launch vibration. In Figure 3, the crew interface is on the left side of the Restraining Bolt, and the shaft to the right of the threads blocks the Release Plunger if the TDA is actuated inadvertently. By design, a small gap is intended between the fully engaged Restraining Bolt and the Release Plunger. This ensures that the Split Spool locks the mechanism and the Restraining Bolt is truly a redundant feature. During initial on-orbit activation, the Restraining Bolt is removed, which arms the TDA. The "Fully Locked" view of Figure 3 shows the TDA armed with the Restraining Bolt backed out from the launch position.

This movement was confirmed on-orbit when the Restraining Bolt required higher than expected torque during removal due to the load being applied to the bolt from the Release Plunger. This was seen again when the Restraining Bolt would not re-engage during failure troubleshooting years later, since the Release Plunger had shifted and created interference. When the gap is closed, the TDA is placed into a partially actuated state which changes the load path within the mechanism. After the failed TDA was returned to the ground a CAD model was created using the as-flown component dimensions. This model further illustrated the gap and clearly showed a discrepancy in the design assembly drawing.

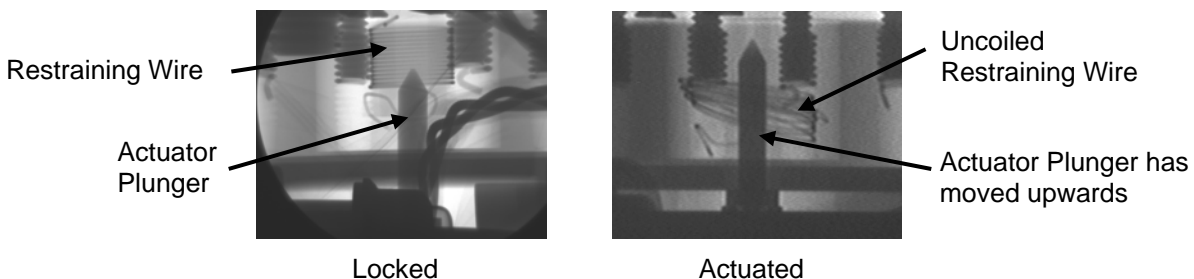
Figure 4. TDA X-Rays

To actuate the mechanism, current is passed through the fuse wire, causing it to weaken and break under load. The Restraining Wire is then free to uncoil; thus it quickly unwinds from the Split Spool (see Figure 4). With the Restraining Wire out of the load path, the spring under the Release Plunger pushes the Actuator Plunger, splitting the two halves of the Split Spool apart as the Actuator Plunger moves upwards. With the Release Plunger clear, the Retaining Pins are forced outward by the T-plunger. Without the Retaining Pins in the load path, the Primary Compression Springs are able to release their stored energy, pushing the T-plunger through the assembly, and driving the cutting blade into the TUS cable. See the actuation sequence in Figure 3.
